**U.S. DEPARTMENT  
OF THE INTERIOR**  
**INTERNATIONAL TECHNICAL  
ASSISTANCE PROGRAM**

# **Introduction to Visual Inspection Of Earthfill Dams**

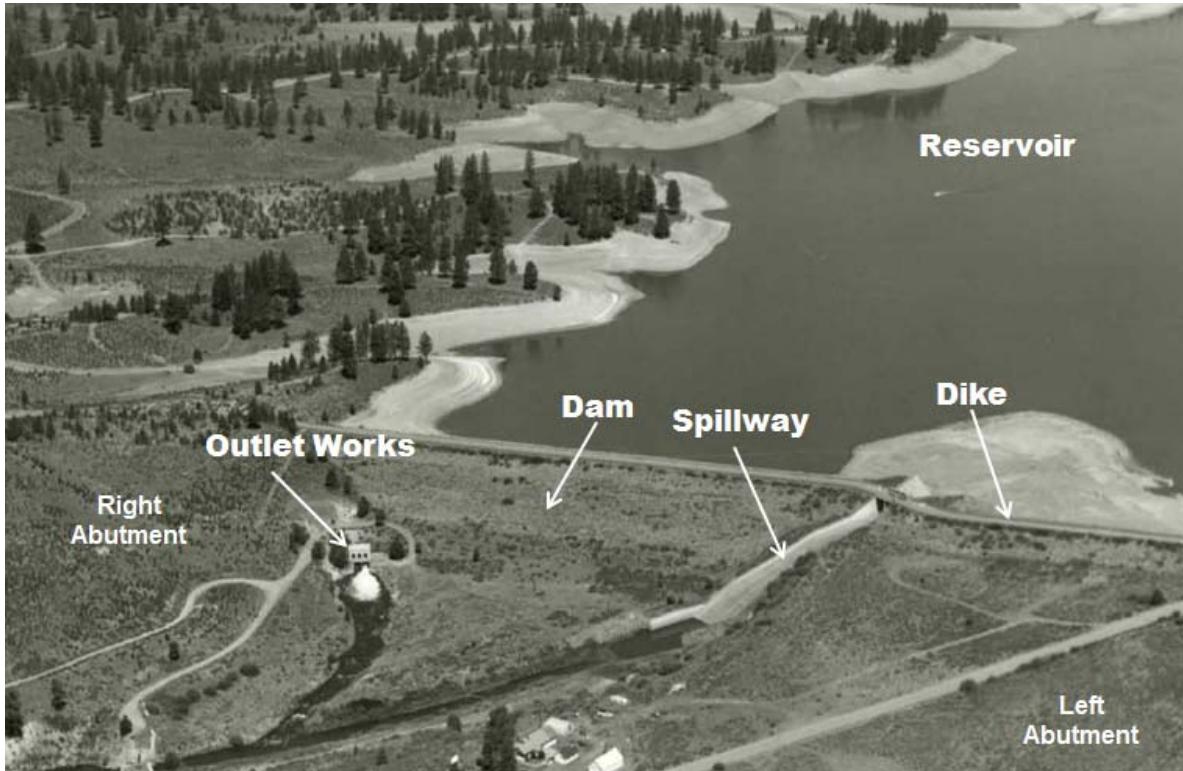
The typical features of an earthfill dam are shown on Figure 1.

Figure 1: Typical Earthfill Dam Features

The dam and dike embankments are the primary water storage barriers and are normally constructed from on-site soil and rock material to limit construction costs.

The spillway is the primary method to pass inflows out of the reservoir to prevent overtopping failure of the dam and dike embankments which may result in dam break. Depending on each particular case, the spillway can be vertical, horizontal, siphon, tunnel, etc. The spillway can be designed with or without control valve. When having a control valve, the reservoir can store a larger amount of water and the water discharge can be controlled more effectively to ensure the safety of primary dam features and downstream area.

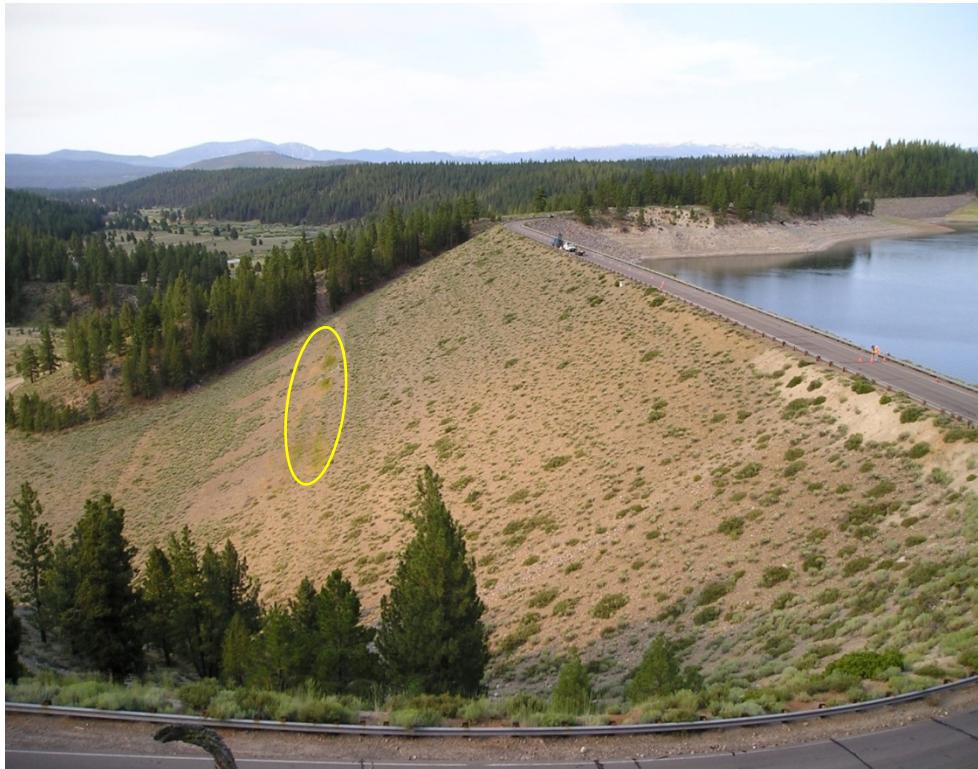
Uncontrolled seepage varies in appearance. Seepage may appear as a wet area or as a flowing “spring.” The appearance of, or changes in vegetation are also good indicators of seepage as shown on **Figure 2**. Areas with a lot of water-loving vegetation, such as cattails, reeds, and mosses, should be checked for seepage, as should areas where the normal vegetation appears to be greener or more lush. These patches of lush vegetation are more obvious in arid environments but may also be seen in Viet Nam.

**Figure 2: Example of Changing Vegetation Due to Seepage**

Viewing the downstream dam face from a distance is sometimes helpful in detecting subtle changes in vegetation. Greener or very lush vegetation below a certain elevation on the downstream face may indicate the intersection of the seepage line through the dam with the slope.

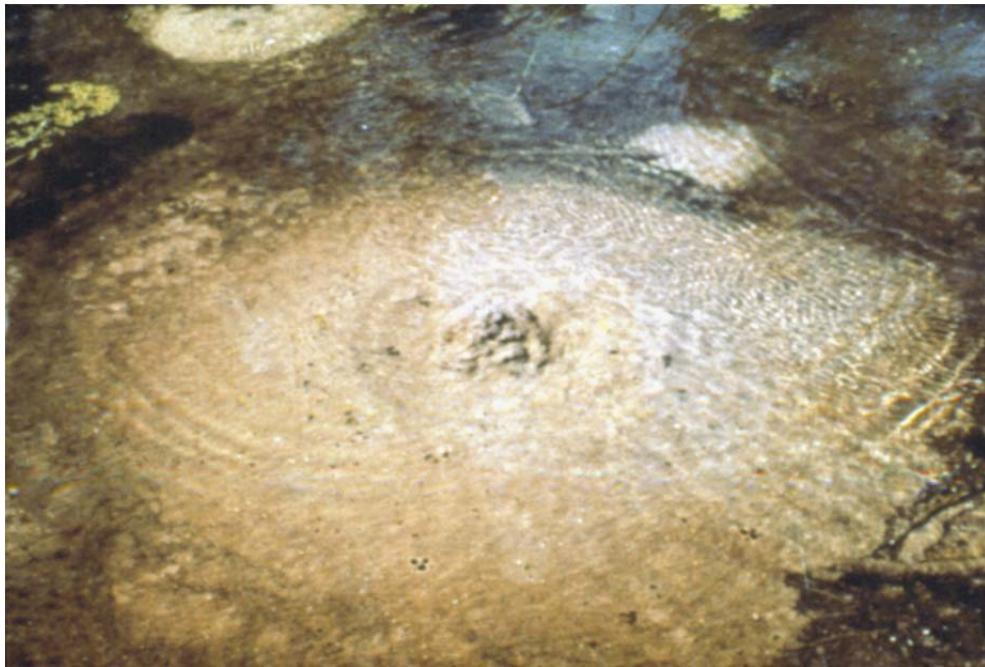
If sand boils like that shown on **Figure 3** are observed they should be photographed and their location documented. The clarity of the exiting seepage should be noted. If there are any deposition cones around the seepage exit points, this should also be recorded. Flow rates should be measured or estimated along with the corresponding reservoir elevation. However, the seepage flow rates may be difficult to ascertain since sand boils are often under water.

Figure 3: View of a Typical Sand Boil

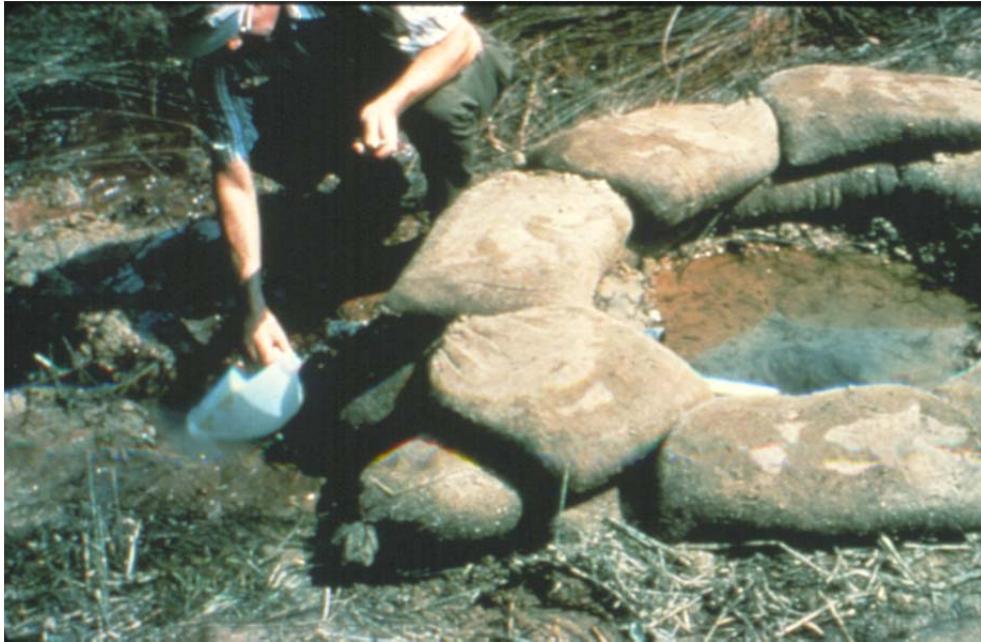
Sometimes as a temporary measure, a sandbag dikeas shown on **Figure 4** can be placed around a sand boil to increase the depth of water over the boil and thereby decrease the potential for internal erosion along the seepage flow path inside the dam or foundation. Conversely, draining a seepage pond at the toe of a dam may increase the potential for internal erosion along the flow path.

Figure 4: View of a Sandbag Dike Around a Sand Boil and Seepage Flow Measurement

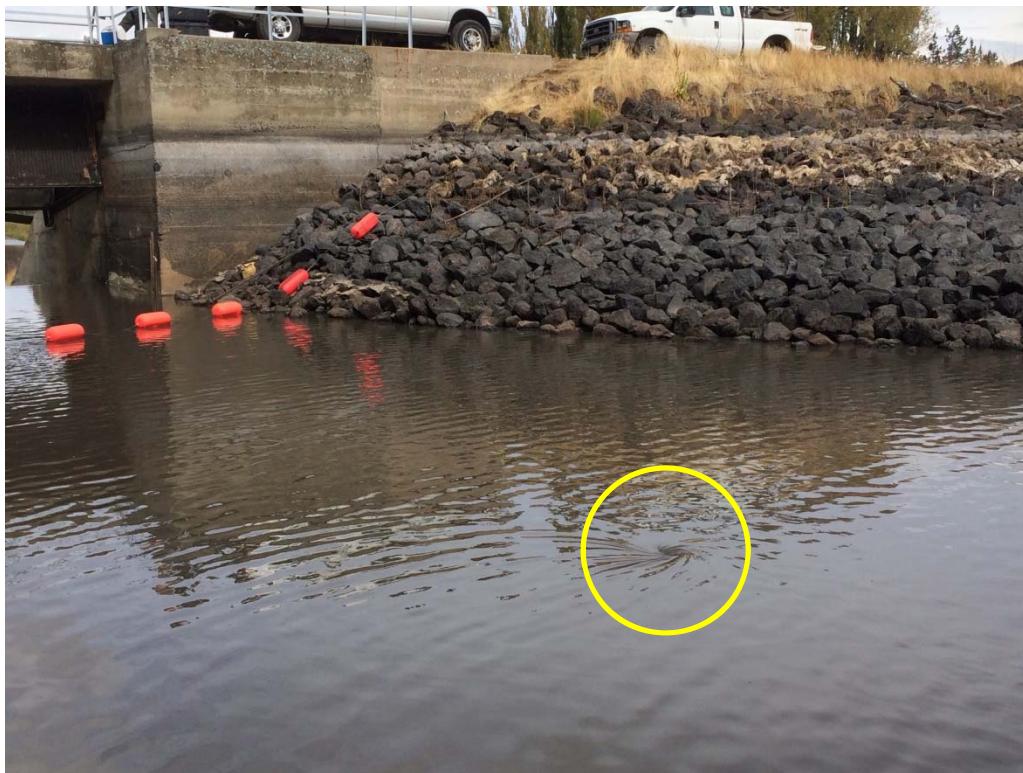
An internal erosion condition does not always appear first as a sand boil. In fact, internal erosion can occur into voids in rock foundations. This type of internal erosion is difficult to detect since nothing is visible until the embankment starts to collapse into the underlying void, or until a vortex appears in the reservoir. A vortex is the rotational movement on the reservoir surface that can appear as water rapidly enters a seepage pathway as shown on **Figure 5**.

### Figure 5: View of Typical Vortex or Whirlpool within the Reservoir

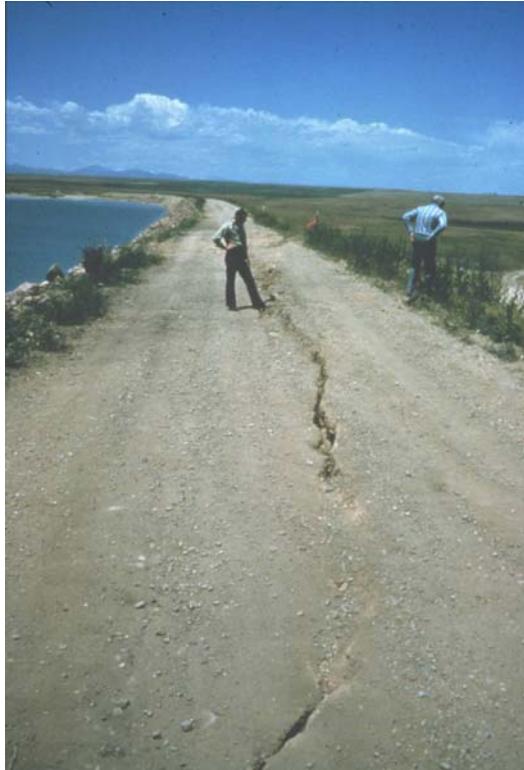
Longitudinal cracking occurs in a direction roughly parallel to the length of the dam as shown on **Figure 6**. It can be an indication of:

- uneven settlement between adjacent embankment zones of differing compressibility;
- excessive settlement and lateral spreading of the embankment; or
- an unstable slope. In this case, the crack may appear arc-shaped.

Figure 6: Example of Longitudinal Cracking

Longitudinal cracks allow water to enter the dam. When water enters the dam the strength of the earthfill material adjacent to the crack may be lowered. The lower strength of the earthfill material can lead to or accelerate a slope stability problem. Longitudinal Cracking: Inspection Actions

If longitudinal cracking is observed the inspector should photograph and record the location, depth, length, width, and offset of each crack observed. Following the initial observation of the crack it and the adjacent embankment should be monitored periodically to evaluate any changes.

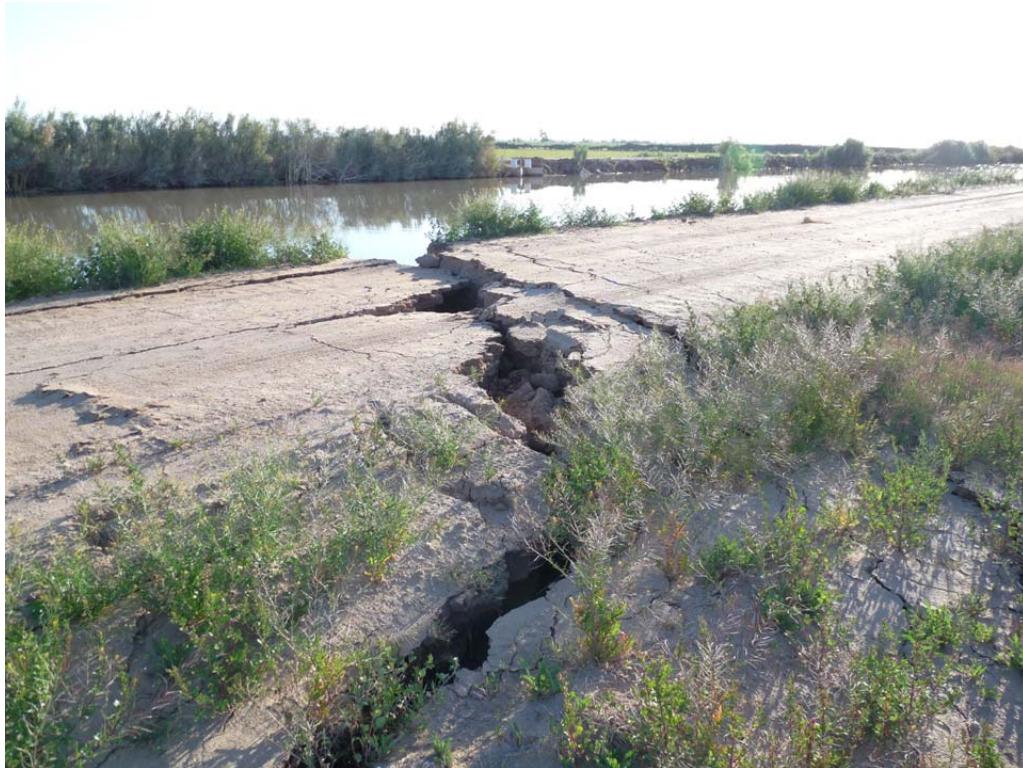
Transverse cracking appears in a direction roughly perpendicular to the length of the dam as shown on **Figure 7**. If these cracks extend into the core below the reservoir level they are especially dangerous because they could create a path for concentrated seepage through the dam core. Transverse cracks usually appear on the dam crest, near abutments, and in U-shaped or trapezoidal-shaped valleys.

Figure 7: View of Severe Transverse Cracking of an Earthfill Structure

The presence of transverse cracking indicates differential settlement within the embankment or underlying foundation. This type of cracking frequently develops when:

Transverse cracks may provide a direct path for seepage through the embankment. When the depth of the crack extends below the level of the reservoir, very rapid erosion of the dam may occur, eventually breaching the dam.

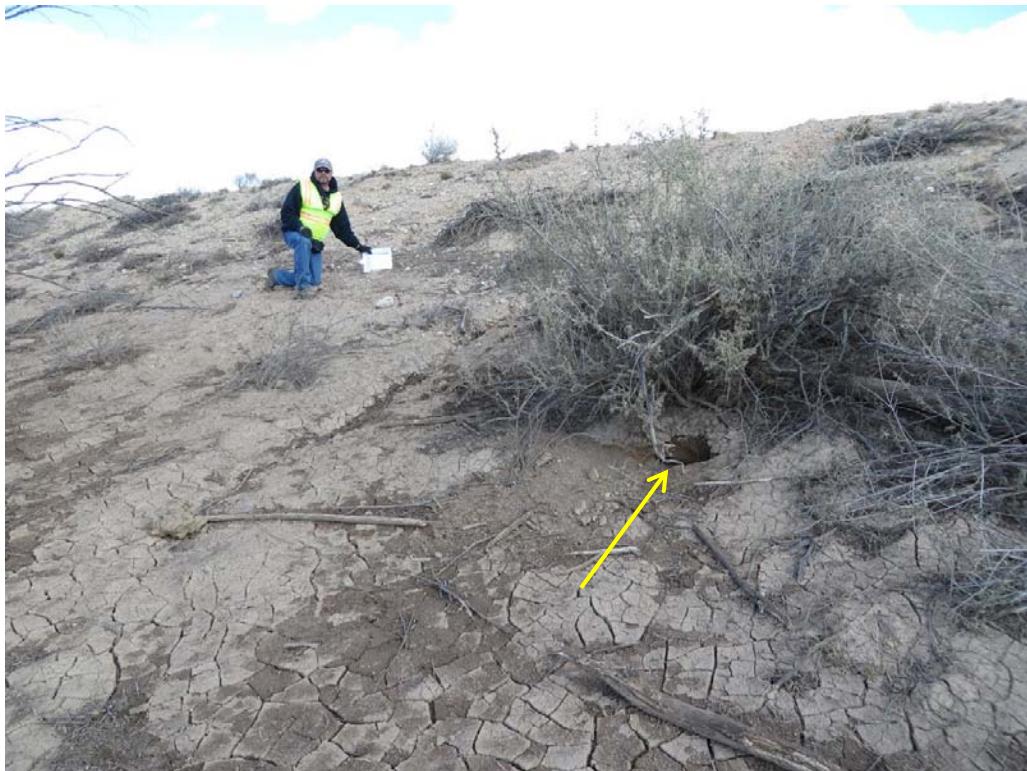
Desiccation cracking is caused by the drying out and shrinking of certain types of soils such as clay. Desiccation cracks usually develop in a random, honeycomb pattern as shown on **Figure 8**. Typically, desiccation cracking occurs in the crest and the downstream slope.

Figure 8: View of Typical Desiccation Cracking (also note the animal burrow at arrow)

Usually, desiccation cracking is not harmful unless it becomes severe. The major threat of severe desiccation cracking is that this type of cracking can contribute to the formation of gullies. Surface runoff erosion concentrating in the desiccation cracks or gullies can result in eventual damage to the dam.

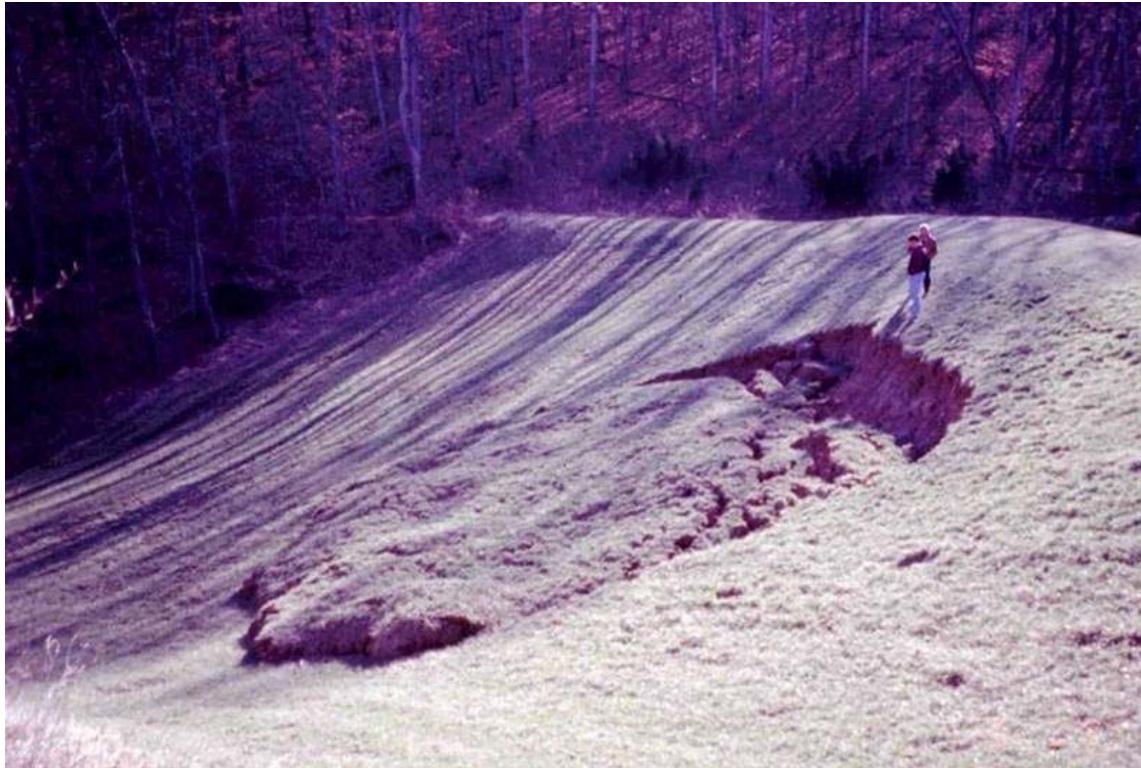
Instability of an embankment can be very serious. Embankment instability is referred to variously as slides, displacements, slumps, slips, and sloughs. An example of a slide feature is shown on **Figure 9**.

Figure 9: View of a Typical Slide Feature Indicating Instability of the Slope

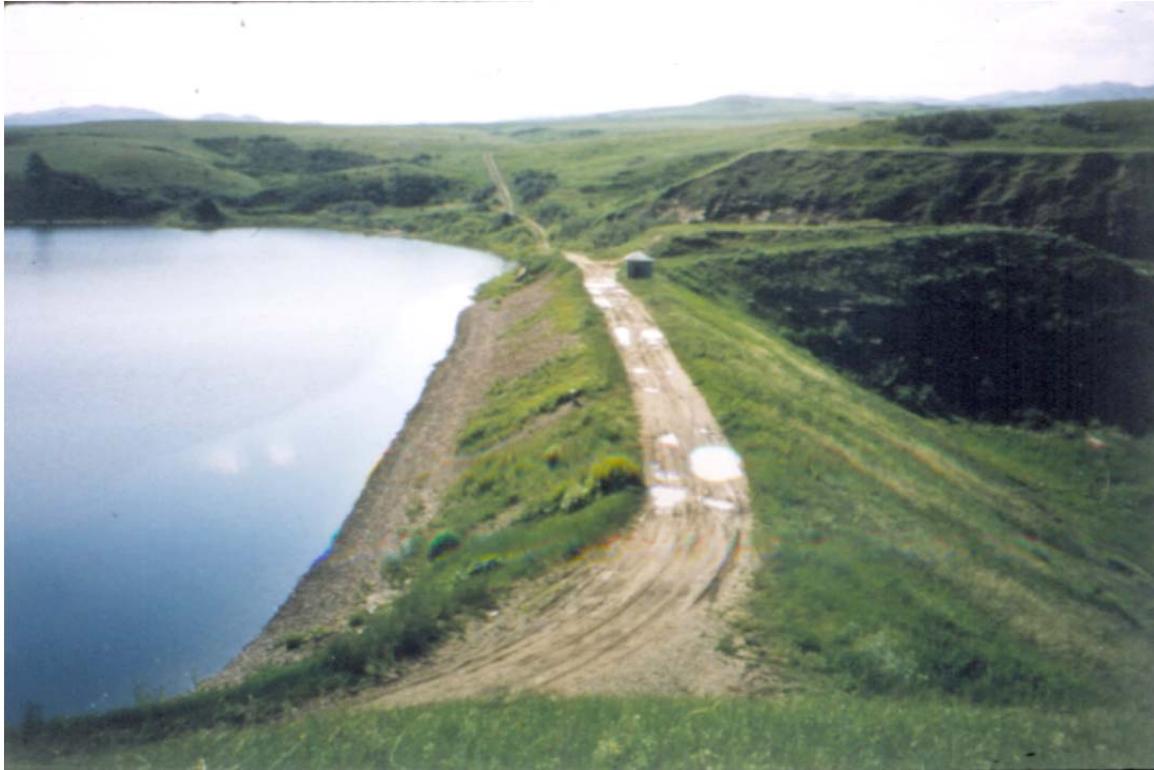
Depressions are low spots in embankment surfaces and may be localized or widespread as shown on **Figure 10**.

Figure 10: View of Depressions on the Dam Crest

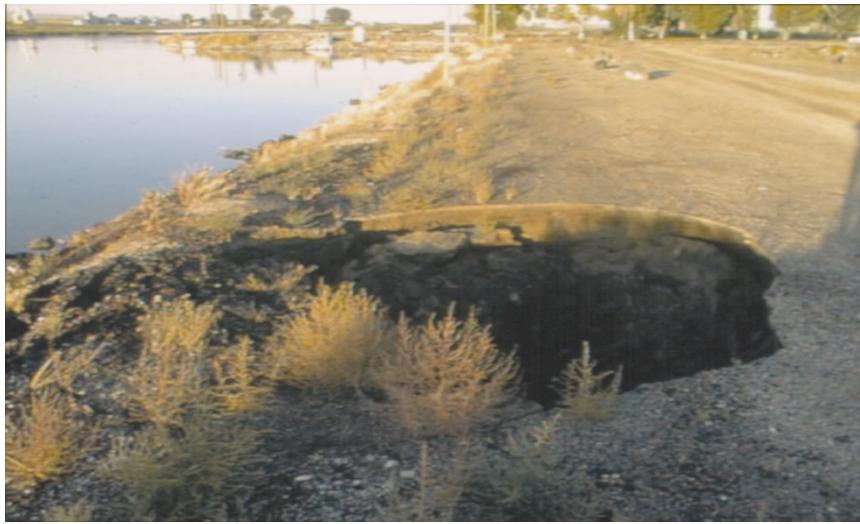
A good way of distinguishing between localized settlement and sinkholes is to look at their profiles. Localized settlement usually has gently sloping, bowl-like sides and is normally larger in area. Sinkholes usually have steep sides from the soil shearing as it collapses into an underlying void (**Figure 11**) and are often smaller in surface area. If a sinkhole is located within the reservoir, the inspector may observe a whirlpool at the reservoir water surface as shown on **Figure 5**. This situation should be considered extremely serious as the internal erosion of the embankment has progressed all the way through the earthfill.

Figure 11: View of a Sinkhole on the Dam Crest (not the near vertical sides)

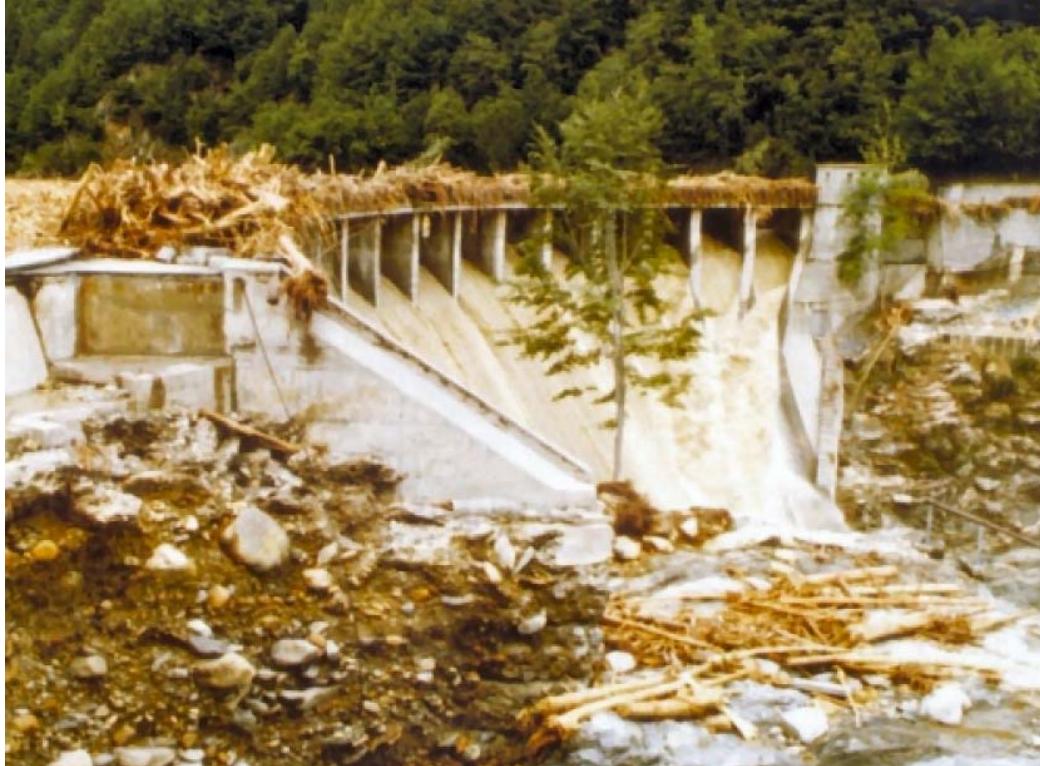
Debris plugging, as the name suggests, involves debris from the reservoir accumulating in the spillway inlet, crest structure, gates (if present), or spillway channel that reduces the ability of the feature to discharge flows at its full capacity. An example of a major debris plugging problem is shown on **Figure 12**. Conditions that contribute to debris plugging problems may not be within the control of the dam operations personnel such as development or wildfires upstream of the reservoir which can contribute to debris loading during flood events.

Figure 12: Example of Major Debris Plugging of Spillway

The inspector should periodically scan the reservoir and its shoreline visually to detect the presence of large debris that could be moved during a flood and carried towards the spillway. Such debris should be periodically removed from the reservoir and disposed of. In addition, all features of the spillway itself should be kept clear of any obstructions that could contribute to debris plugging problems. During spillway discharges on-site personnel should periodically monitor for debris plugging problems. If debris begins to become a concern, sometimes it can be dislodged and guided downstream by the flow before significant buildup and plugging has occurred.

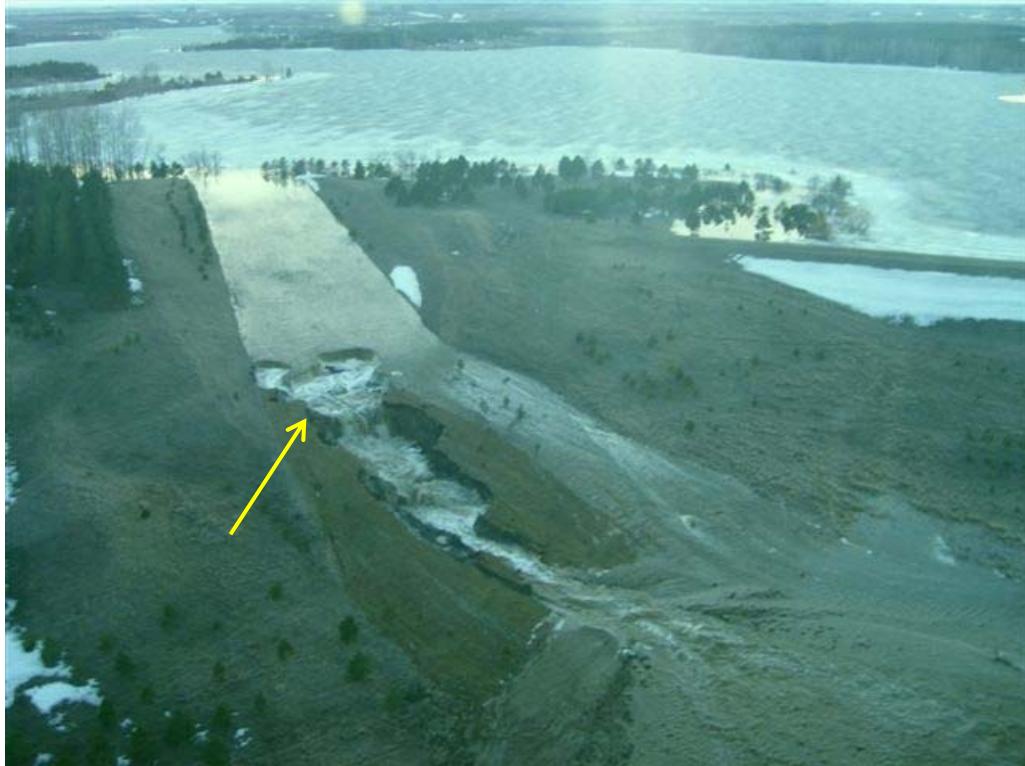
Spillways walls and channels can be composed of a variety of materials including: concrete; rock or masonry; or perhaps soil. Each of these materials has different resistance to erosion by spillway flows. Spillway erosion can lead to failure of the spillway and eventually to breach of the dam in some cases. An example of spillway erosion is shown on **Figure 13**.

Figure 13: Example of Significant Spillway Erosion (at arrow)

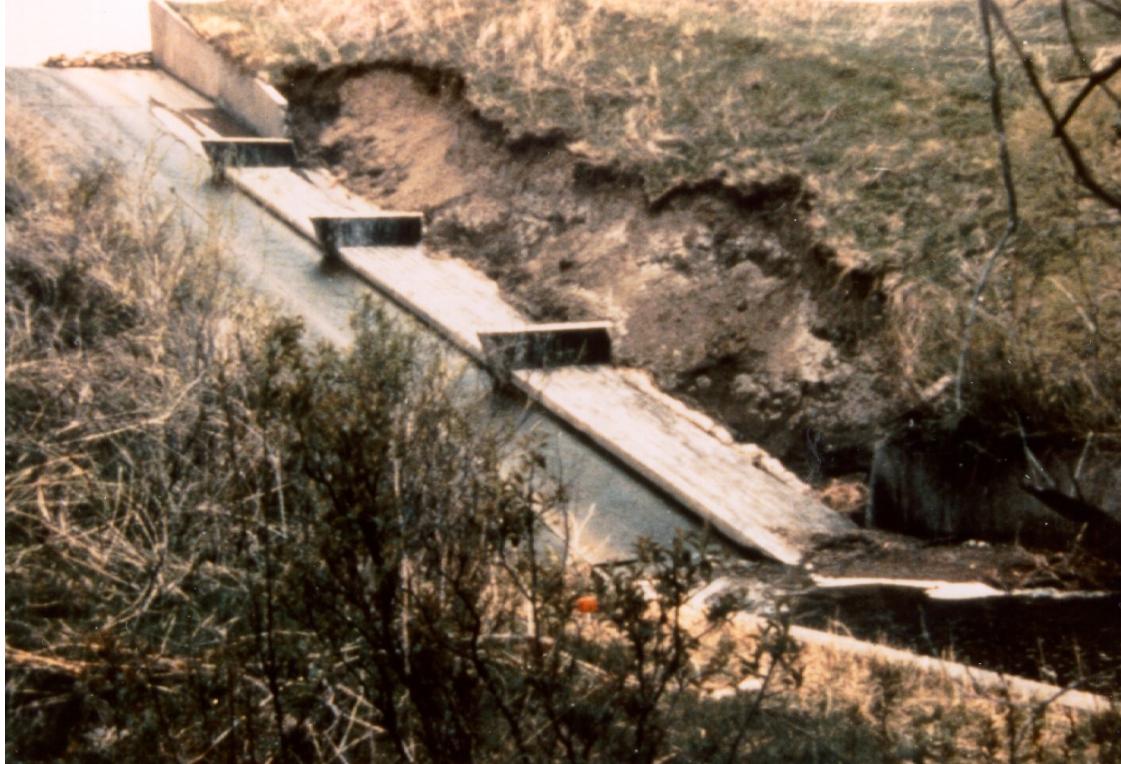
Instability of the spillway or stilling basin walls involves sliding or overturning of the walls along the sides of the structure as shown on **Figure 14**. The inspector should look for cracking, tilting of the walls, or offset joints or cracks along the wall alignment. In addition, the inspector should look for signs misalignment along the length of the walls.

Figure 14: Overturning Instability of the Spillway Wall

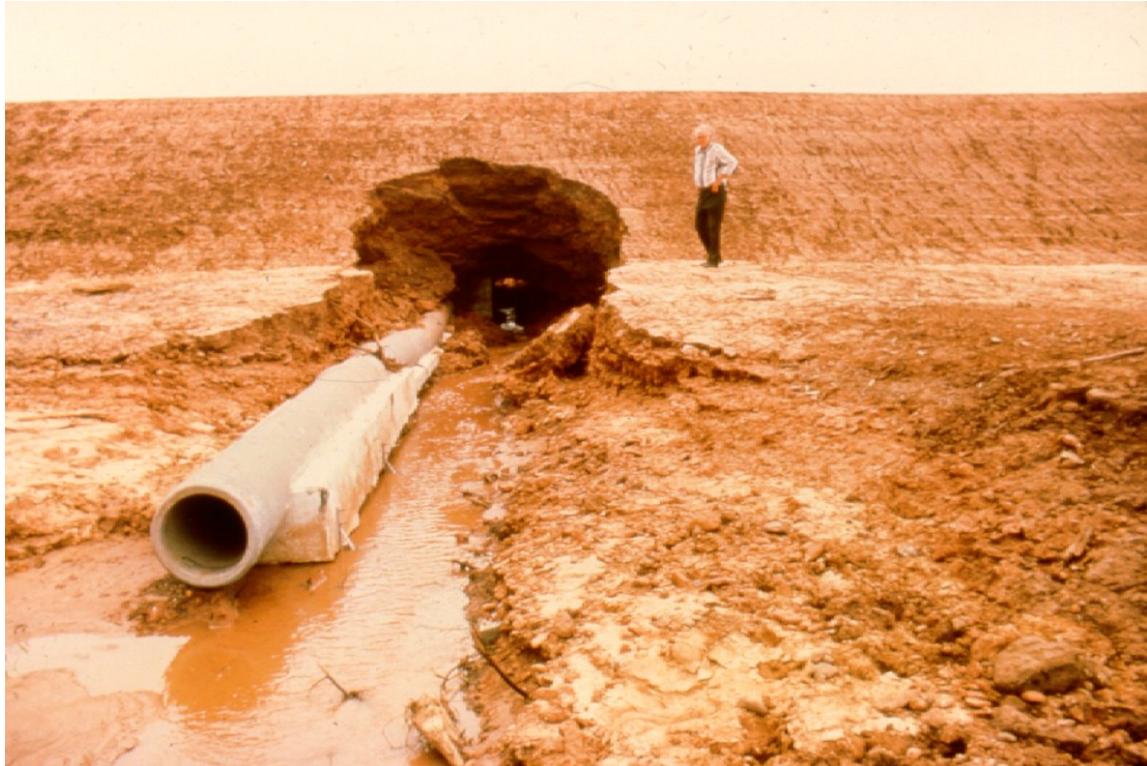
As mentioned previously, penetrating conduits are related to a large percentage of earthfill dam failures. The poorly compacted backfill surrounding the conduit often allows for more significant seepage quantities and velocities that can contribute to internal erosion inside the earthfill structure. Holes or offset conduit joints can allow embankment soil to be eroded into the conduit or can allow pressurized water from the conduit to penetrate the surrounding earthfill contributing to internal erosion. Failure of an earthfill dam due to seepage adjacent to the outlet works conduit is shown on **Figure 15**.

Figure 15: Internal Erosion Failure Due to Seepage Along the Outlet Conduit

As a result, the earthfill in the vicinity of the outlet works (or any penetrating conduit) should be inspected thoroughly. Depressions or sinkholes visible at the ground surface along the conduit alignment should be considered a very serious condition which may indicate that internal erosion has initiated and progressed to an alarming state. The ground surface near the conduit outlet should also be visually checked for seepage and any soil being transported by the flow.

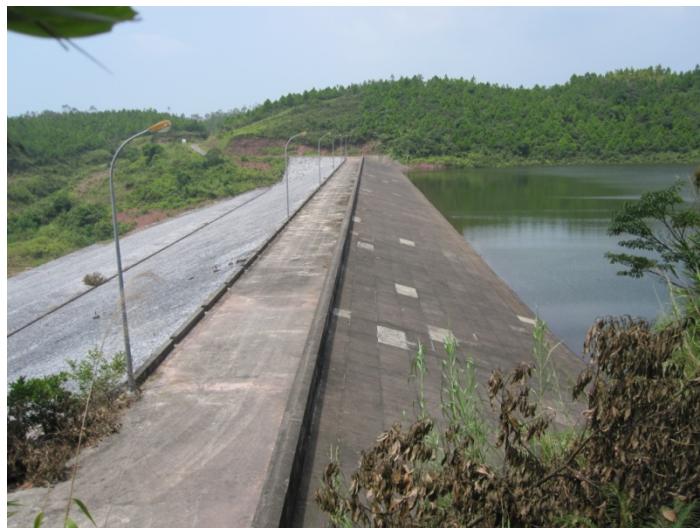
**Figure 16. General view of Trang Vinh dam, Quang Ninh province**

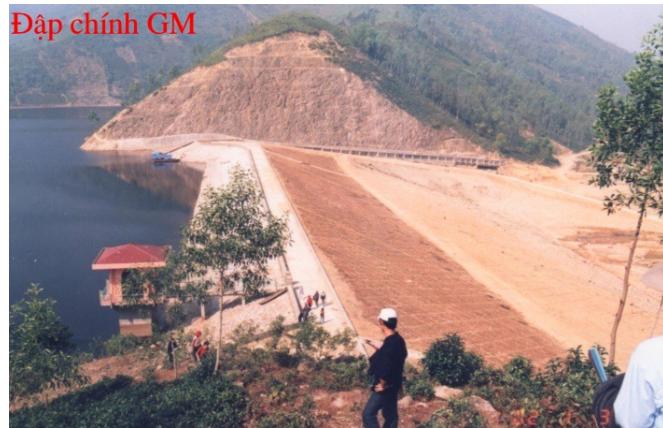
Figure 17. Starting area of Go Mieu lake – Thai Nguyen
